EFFECTS OF ION-PLATING ON LOW CYCLE FATIGUE BEHAVIOR
OF COPPER SINGLE CRYSTALS

A THESIS

By
Edmund Yung Chen

Georgia Institute of Technology

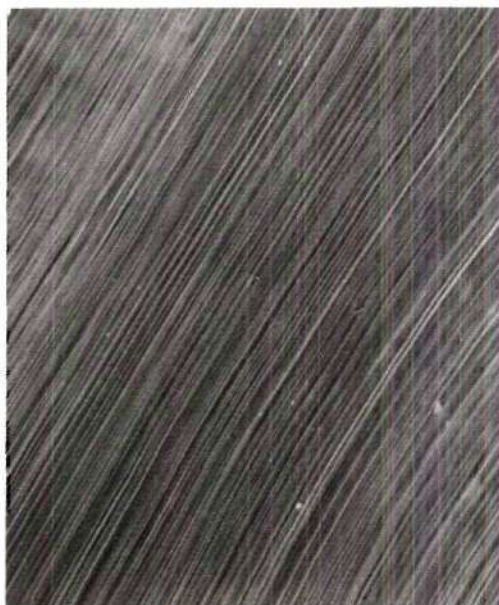
Figure 15. Scanning Electron
Micrograph of the Pure
Copper Crystal Surface
Fatigued at $\frac{\Delta\epsilon_T}{2} = \pm 1$
Percent
(a) After 30 Cycles
(b) After 300 Cycles
(c) After 1200 Cycles

Slip bands spread across the whole gauge section until the initial saturated state was reached. These bands belonged to the primary slip system and were uniformly distributed. Figure 15a is a scanning electron micrograph of pure copper surface after 30 cycles. As fatigue continued, slip traces of the secondary slip system were observed. However, the steps of these secondary surface markings were much shallower than the primary slip bands and were widely separated, Figure 15b. The superficial appearance of the original slip bands did not change appreciably, but it is evident that some slip bands become more active than the others. The step-heights of these bands increased gradually. As a consequence of the concentrated surface rumpling, microcracks were formed. Figure 15c is an example of the surface topography after 1200 cycles at $\frac{\Delta\epsilon_T}{2} = \pm 1$ percent.

at the same conditions as the pure copper crystal shown in Figure 15. The similarity of slip traces of the coated surface with that of the uncoated crystal indicates that the coating film was epitaxial with the copper substrate. Otherwise, more random slip traces should have been observed on the coating film due to the Taylor criteria of polycrystalline deformation. The epitaxial nature of the coating was confirmed by both x-ray diffractometer traces and back reflection Laue patterns.

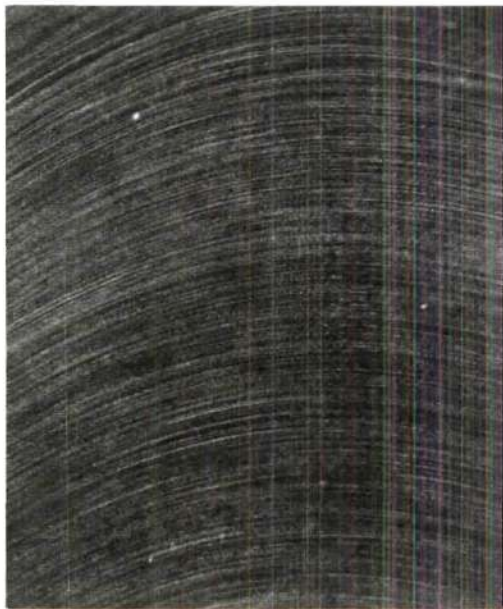
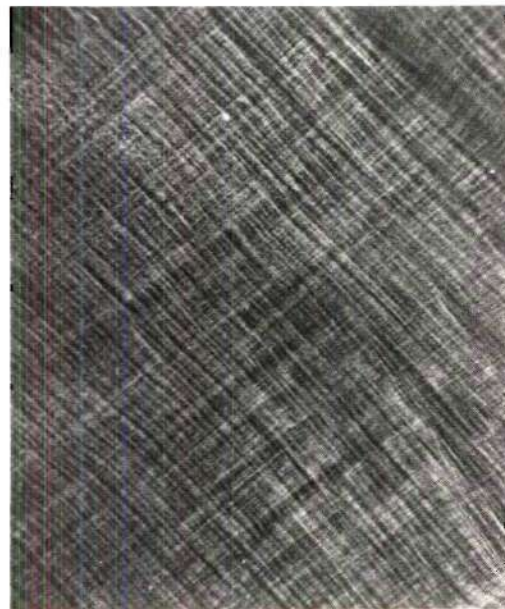
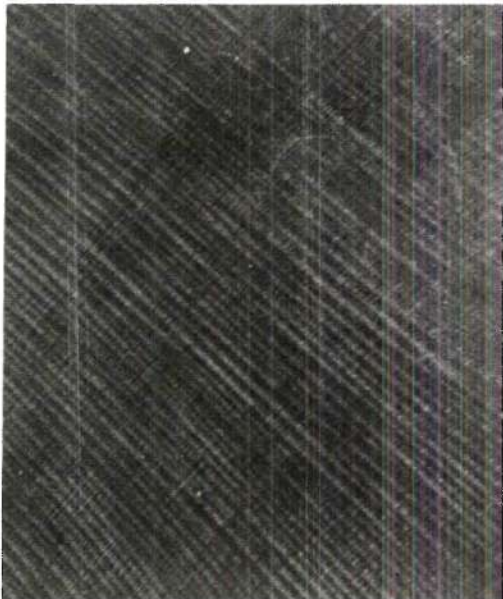
Figure 16. Scanning Electron
Micrograph of the
Silver Plated Crystal
Surface Fatigued at
 $\frac{\Delta\epsilon_T}{2} = \pm 1$ Percent
(a) After 30 Cycles
(b) After 300 Cycles
(c) After 1200 Cycles

The surface observation described above are generally valid for all systems. Figure 16 and Figure 17 are respectively the silver plated and nickel plated crystals fatigued

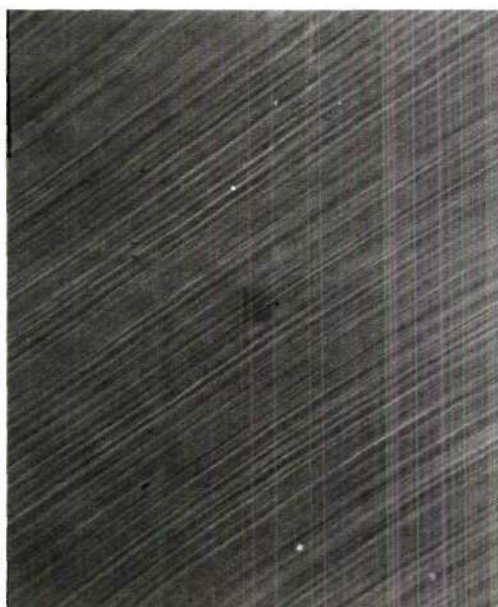
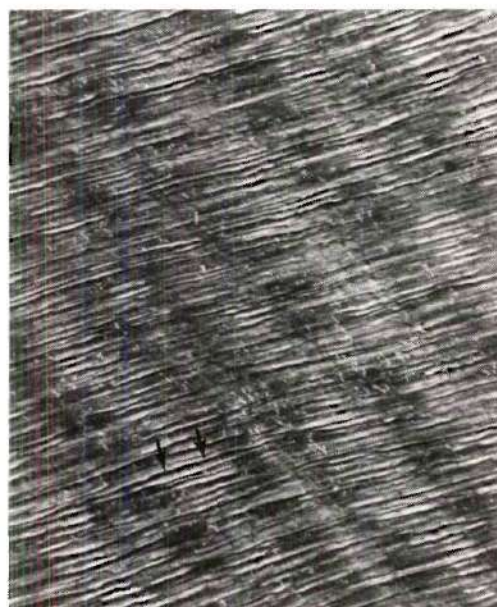
Figure 17. Scanning Electron
Micrograph of the
Thin Nickel Plated
Crystal Surface
Fatigued at
 $\frac{\Delta \epsilon_T}{2} = \pm 1$ Percent
(a) After 30 Cycles
(b) After 300 Cycles
(c) After 1200 Cycles

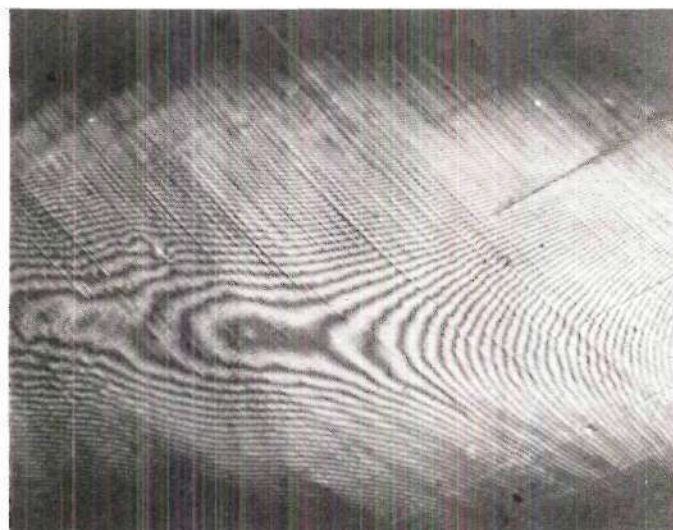
Figure 18. Interferogram of the Silver Plated Crystal
Fatigued at $\frac{\Delta \epsilon_T}{2} = \pm 1$ Percent (a) After 300
Cycles, (b) After 1200 Cycles

Figures 18a and 18b are the interferograms of the silver plated specimens after 300 and 1200 cycles fatigued at $\frac{\Delta\epsilon_T}{2} = \pm 1$ percent. No quantitative measurement was made because of the limited focused area on such a small cylindrical surface. But qualitatively it indicated that the shifting of the interference fringes across some of the slip bands increased with the cycling. The step-height equals to $\lambda \cdot \frac{x}{2h}$, where λ is the wavelength of the monochromatic mercury light (5460 Å), h is the measured spacing of the parallel fringes on the interferogram, and x is the displacement of the fringe across the slip band.⁴¹

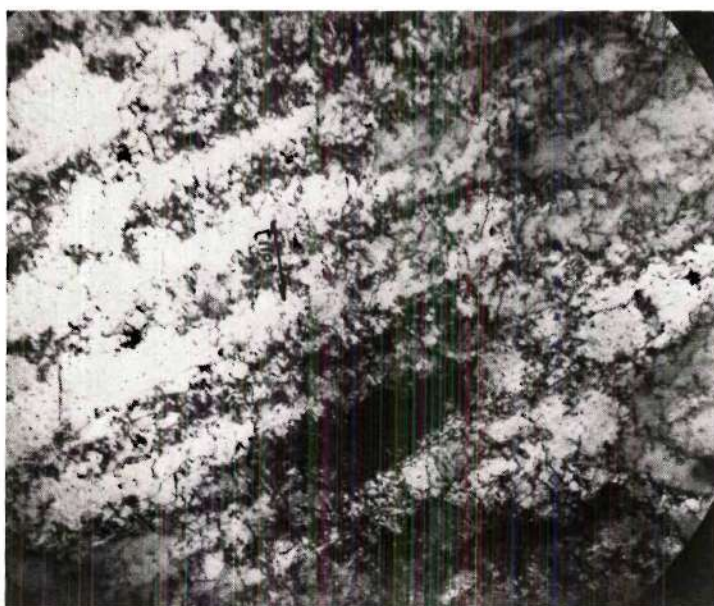
cell structure is readily apparent on both the primary slip and the conjugate slip planes, Figure 21a and 21b. The cell wall width ranges from 2000 to 4000 Å. The average spacing between the walls is about 1 μm . The density of dislocation dipoles and loops in the cell walls have decreased substantially from that observed after 30 cycles. Tangled and jogged dislocations which fragmented into dense tangles of shorter segments now are the dominant features. Some dislocations lying across the interior of cells are seen on primary slip plane (Figure 21a). A very large number of round small black features are observed on the conjugate slip plane, Figure 21b. These have been previously suggested to be the agglomeration of point defects produced during fatigue.⁴²

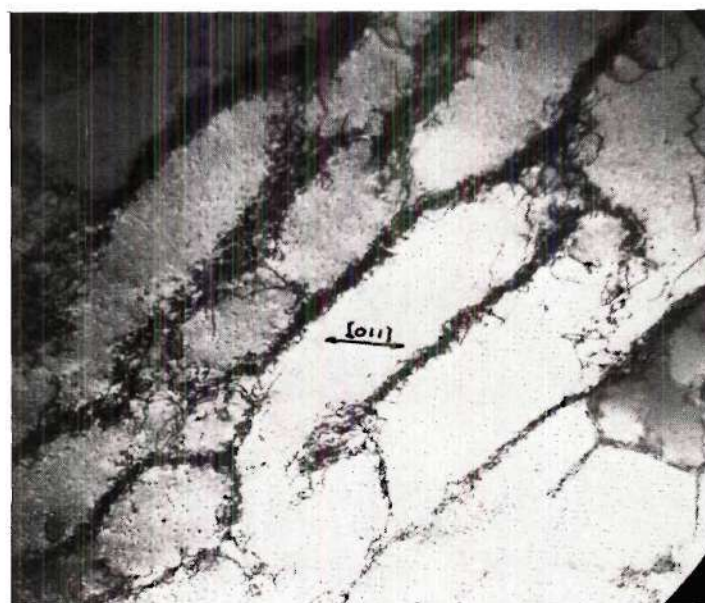
individual dislocations between the cell walls, and the cells are not so well aligned in an unidirection as was observed on the primary slip plane. Figure 22b is a micrograph of the $(\bar{3}\bar{2}3)$ plane, which is only slightly off the conjugate slip plane, $(\bar{1}\bar{1}1)$. On both the primary slip plane and the conjugate slip plane, microtwins were observed, Figure 22a, 22c. Since the formation of these twins can be produced only after large amounts of plastic deformation in copper crystals, these features were only observed after 1200 cycles of fatigue.

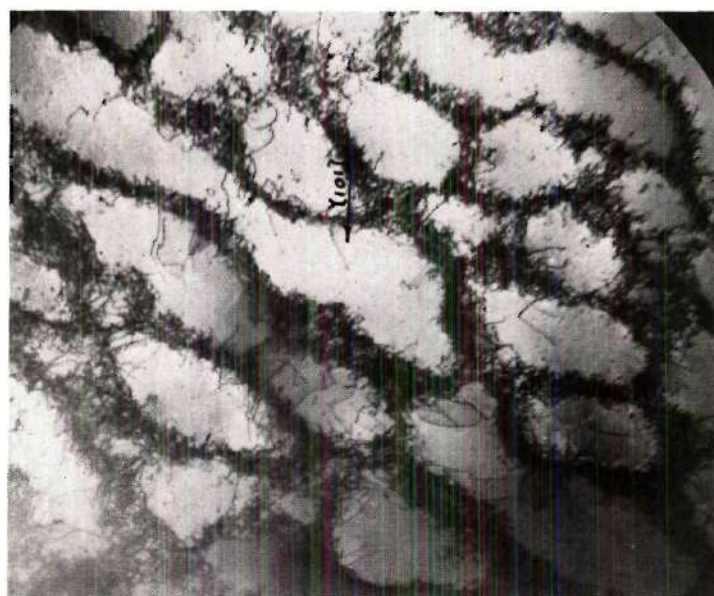
Figure 22. Transmission Electron Micrograph Showing Dislocation Structure in Fatigued Copper Crystal After 1200 Cycles on (a) $(3\bar{2}3)$ Plane Which is 10.02° from the (111) Primary Slip Plane (b) and (c) $(\bar{3}\bar{2}3)$ Plane which is 10.02° from the Conjugate Plane $(\bar{1}\bar{1}1)$
